EVALUATION OF EXISTING CONDITIONS

Countryside Elementary School & Site Existing Conditions Report

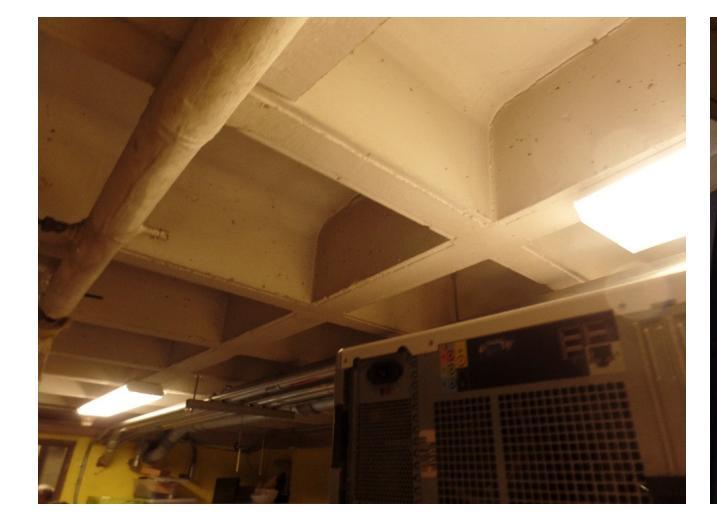
Photo No. 1: Concrete joist first floor slab over basement

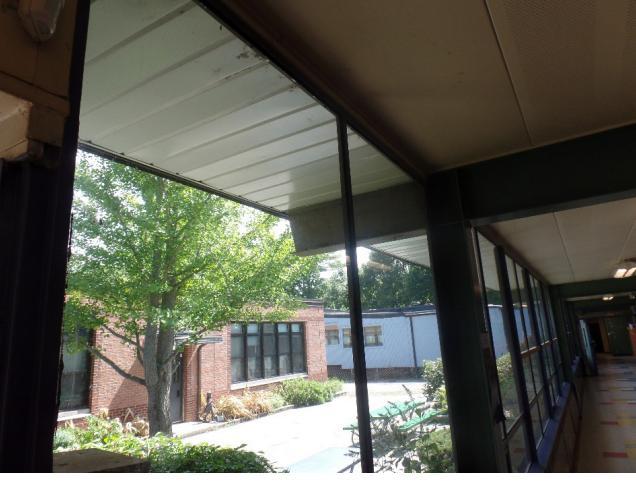
Photo No. 2: 1957 addition roof structure

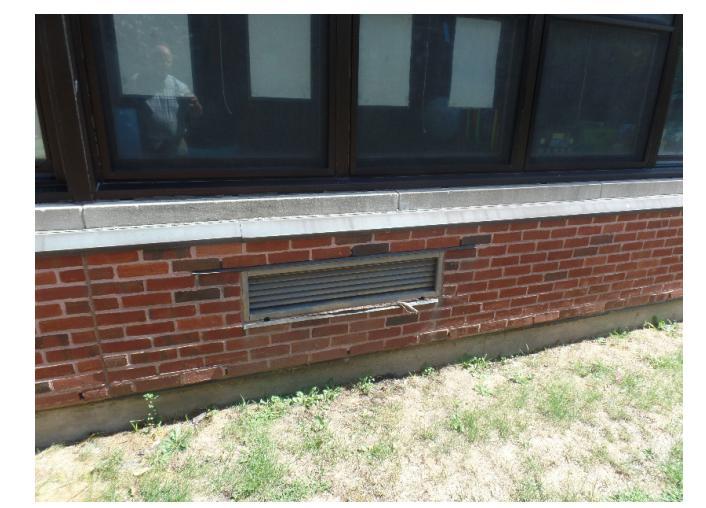
- Loose lintels over window/door openings and above unit ventilators have rusted in some locations; cleaning and coating with zinc-rich paint or replacement (if necessary) is recommended. Note that the unit ventilators are located close to the exterior grade and require maintenance during the winter months.

Photo No. 5: Unit ventilator grille at 1951 original building

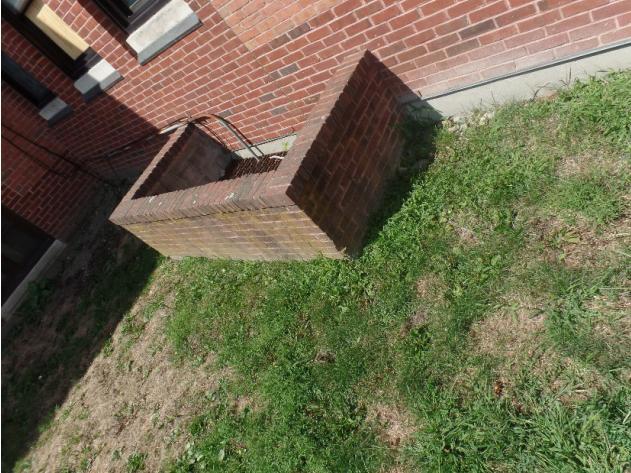
- Exterior concrete elements (brick areaway walls and stair/ramp walls, etc.) have deteriorated in some locations; Repair/replacement of these elements should be undertaken, in conjunction with a potential future renovation of the building.

Photo No. 6: Brick deterioration at 1951 building areaway walls

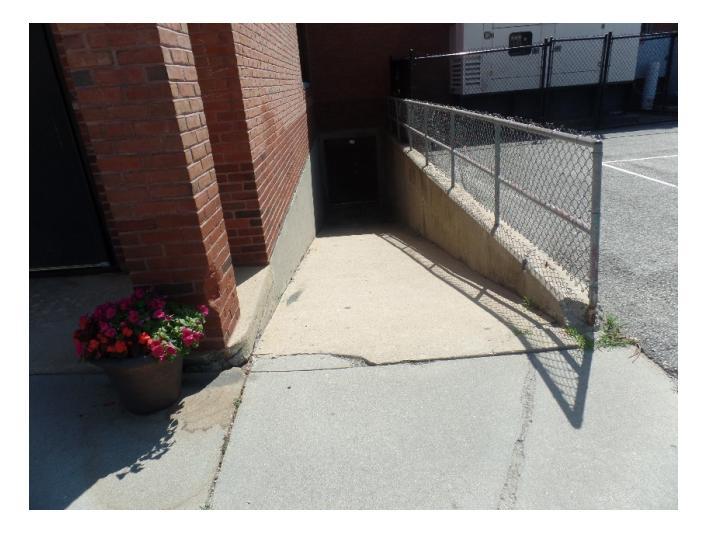
Photo No. 7: Exterior ramp to 1951 basement

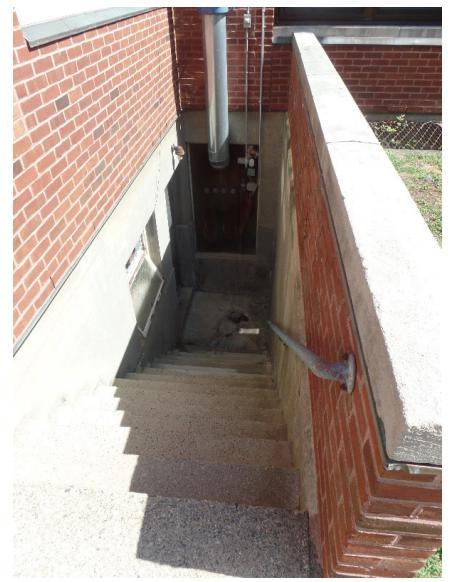
Photo No. 8: Exterior stair to 1951 boiler room

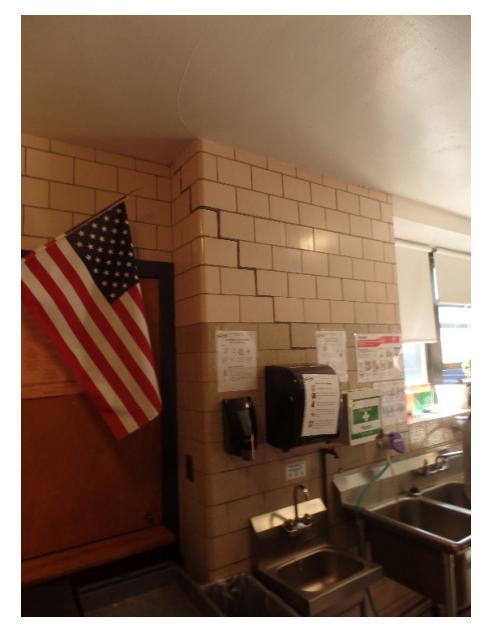
- 3. Exterior:
 - Masonry veneer is generally in satisfactory condition, with limited cracking or deterioration • of the face brick observed. Repointing of approximately 5% of exterior brick veneer may be needed, in conjunction with a potential future renovation of the building.

Photo No. 9: Step cracking in masonry in 1951 building

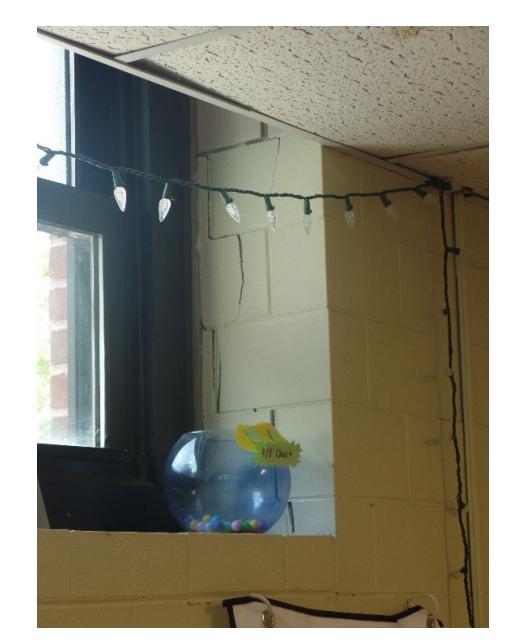
Photo No. 10: Cracked masonry at 1951 west wall window jamb

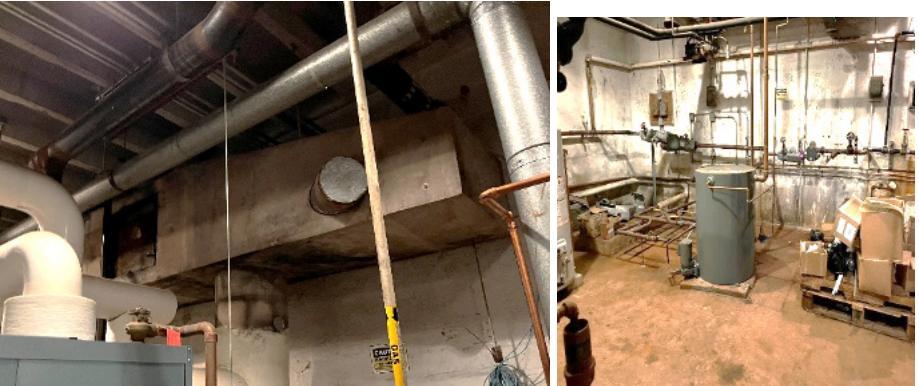
L - Original vintage boiler breeching. R - Recently replaced condensate receiver, but all the piping are the original. Note that entire floor is deeply stained from chronic flooding.

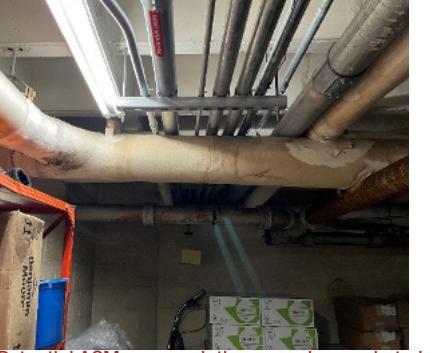
Potential ACM encapsulation was observed at pipe fitting insulation.

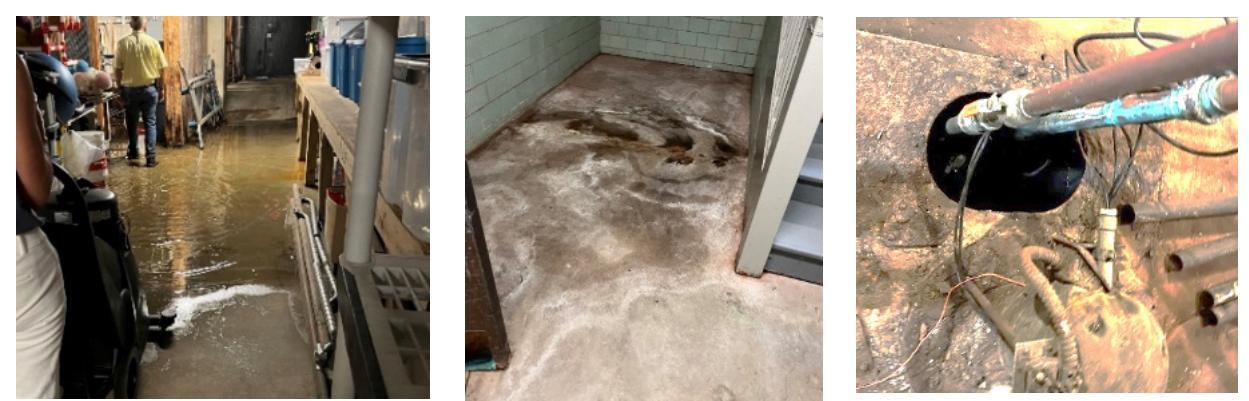
L&C - Chronic flooding of basement level. R - One of numerous sump pumps, which have to be replaced frequently due to its nearly continuous operation.

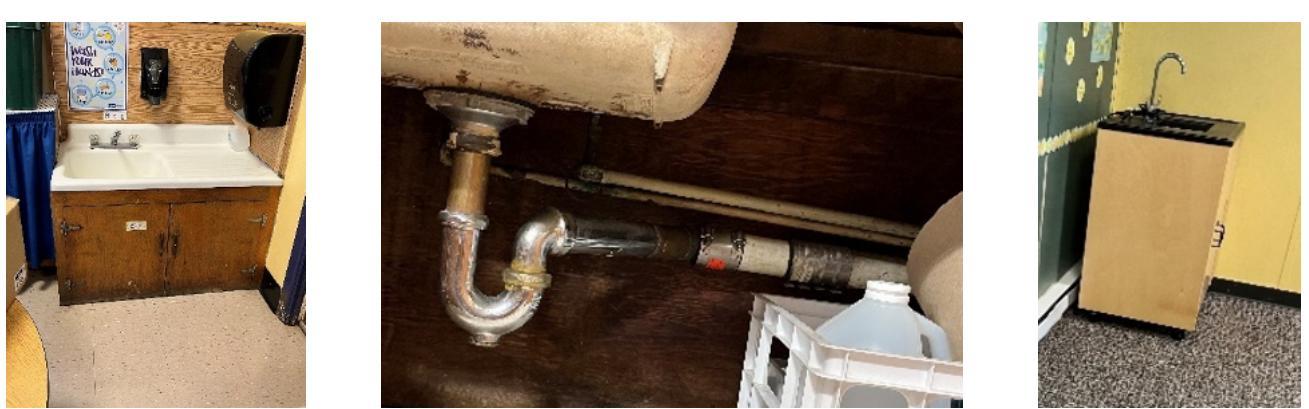
L - Typical classroom original vintage sink. C - Inspection shows that waste piping has been repaired numerously using a PVC pipe section and neoprene plumbing patches.

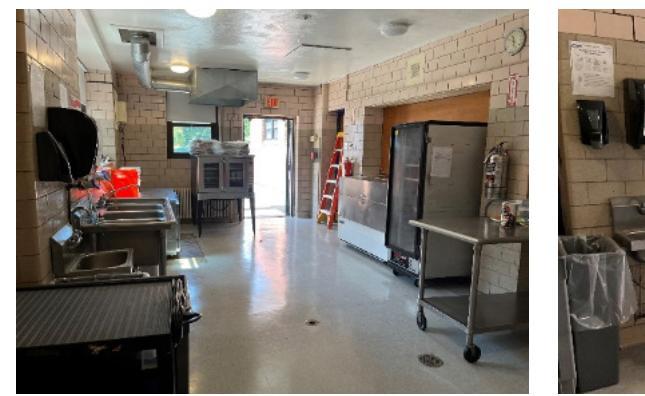
L - Kitchen is not a full cooking type but just a warm-up and preparation type. R - Note that section of hand sink waste piping has been replaced with non-compliant PVC piping; grease interceptor could not be located.

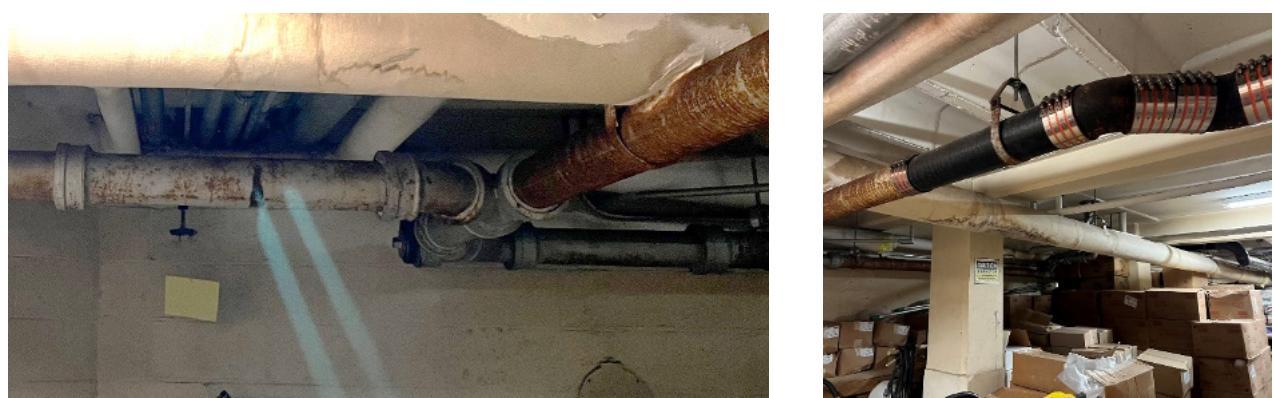
L - Shows original vintage cast iron waste piping in basement with lead / okum packing, showing exterior corrosion. R - Same area shows extensive portion which has been replaced.

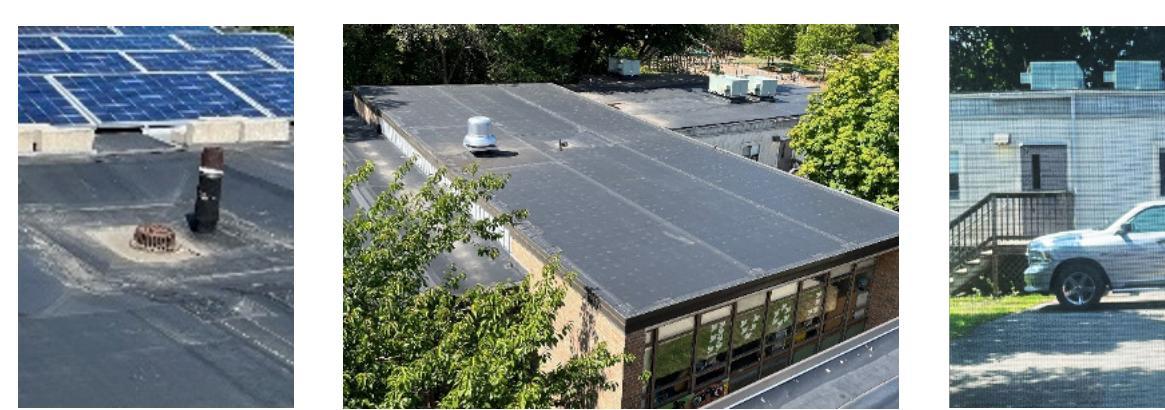
L&C - Original roof drains without overflow. R - Modulars have downspouts.

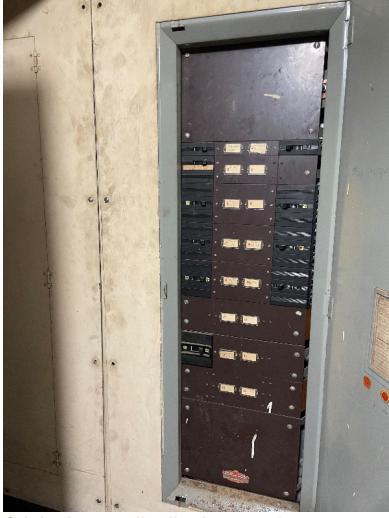
Despite being maintained by the owner; many of the 1951 and 1957 electric service panels are still operational, and well past their life expectancy.

Original 1953 distribution panel

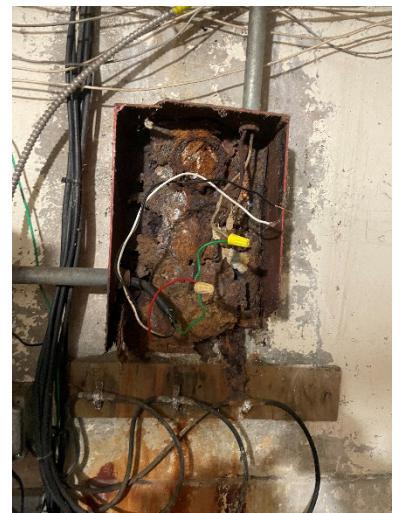
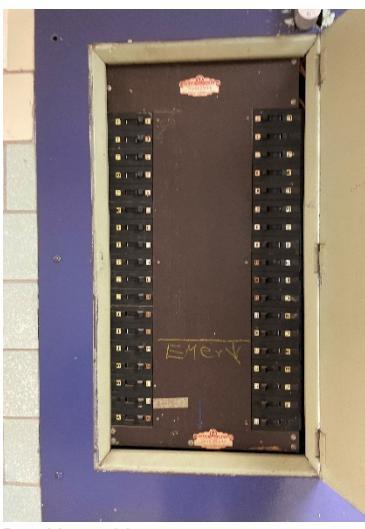
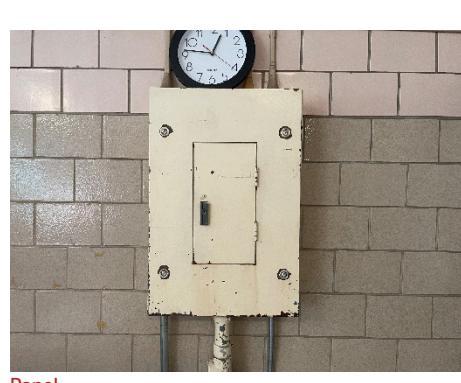
Water infiltration has been an issue in the basement. All electrical equipment including the main electric service equipment is vulnerable to water damage.

Water damaged equipment

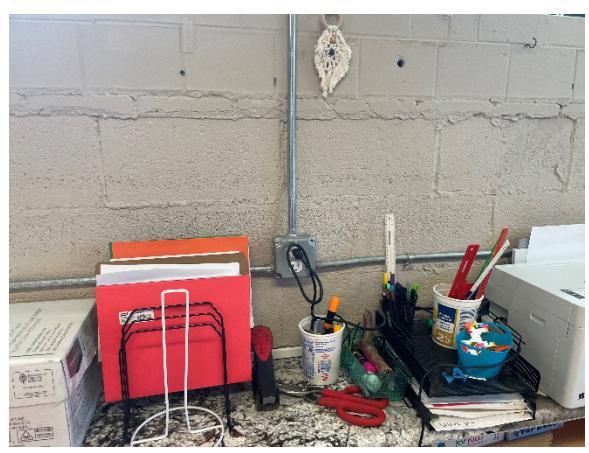
Power strips are being used in several areas. Power strips are a fire hazard to use. With the minimum number of circuits, power strips can easily overload a circuit.

Power strip / Receptacle

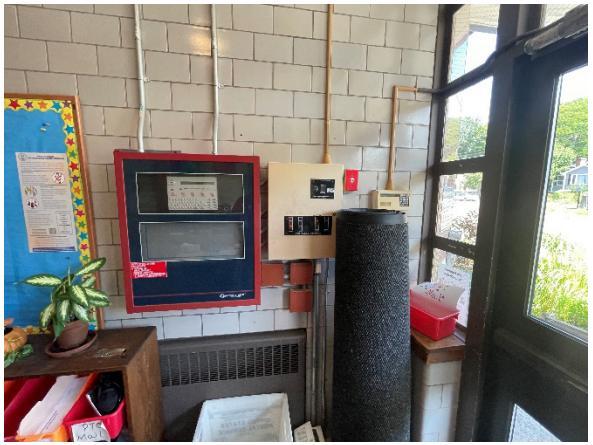
The fire alarm system is in poor to failing condition, well past its life expectancy, and needs to be replaced.

Control Panel

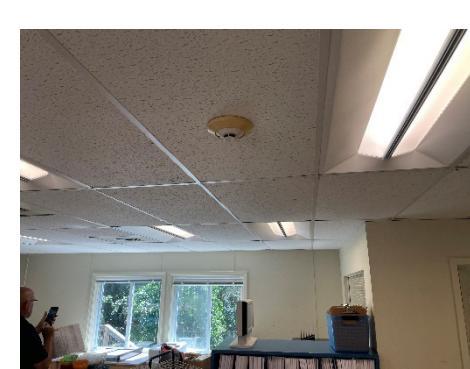
New detector in old base

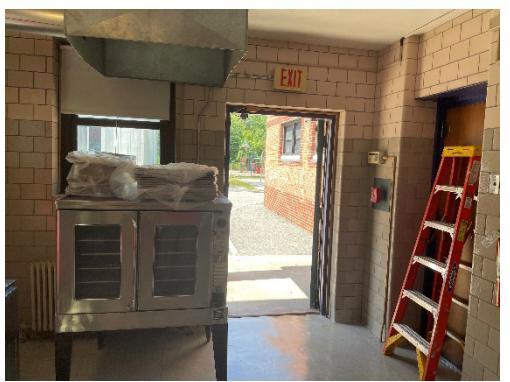
Exit sign not working
