EVALUATION OF EXISTING CONDITIONS

Countryside Elementary School & Site Existing Conditions Report

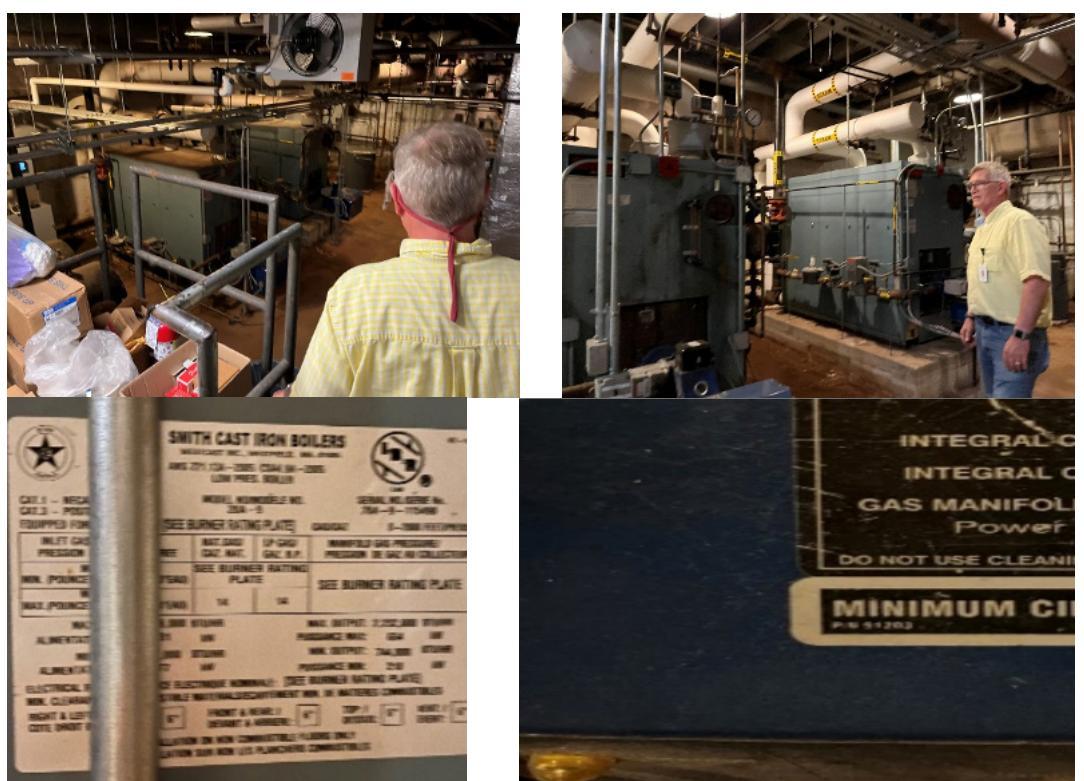
Two gas fired Smith cast iron low-pressure steam boilers with 2.8 million BTUH input Power Flame burner. The boilers were replaced in 2007 and 2012. School was converted to gas in 2011. Boiler room has been flodded numerous times over the years.

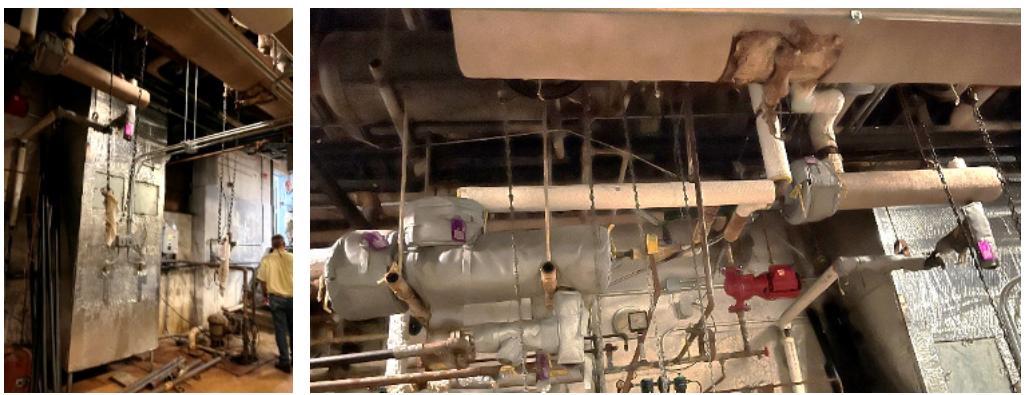
L - Boiler combustion air. R - Steam to hot water converters

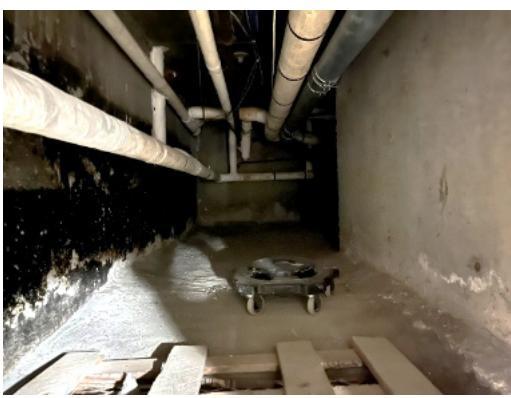
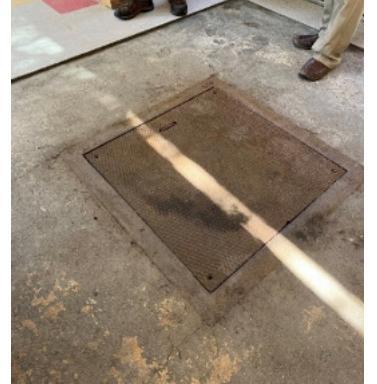
L - Pipe space runs along the perimeter to feed the radiators and unit ventilators.

R - One of the many access panels to the pipe space

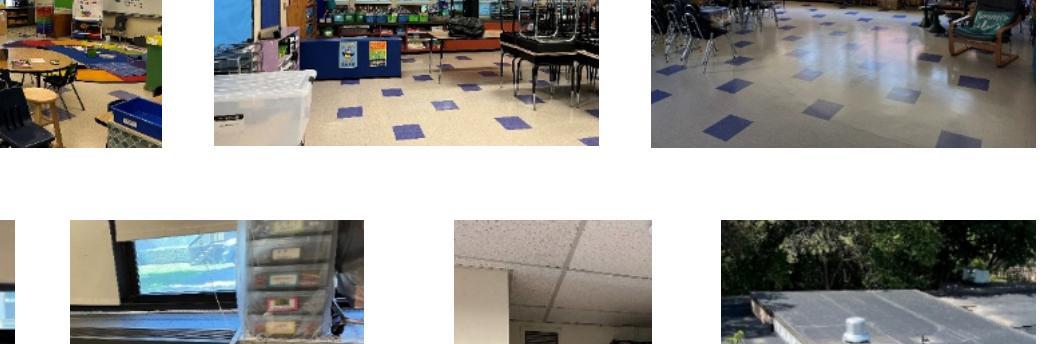
Typical classrooms are heated and ventilated by unit ventilators (L & CL) and wall exhaust (CR), which would not meet today's teaching environment acoustical requirements. R - Central roof exhaust fan assure

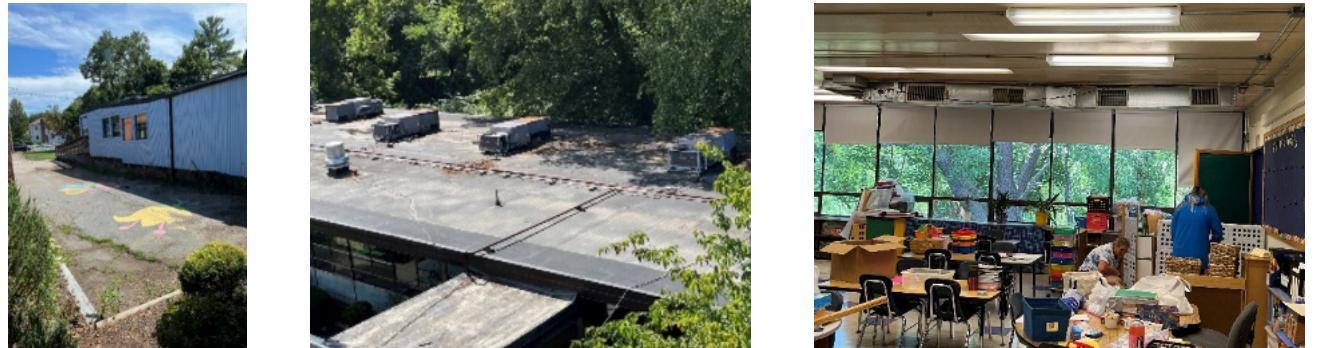
L - Modular annex with end mounted trailer home type AC unit. C - 1958 Annex with gas rooftop provides HVAC for the classrooms. R - Exposed ductwork with no attenuation on return ductwork, resulting in noise level far above what is considered acceptable in today's teaching environment.

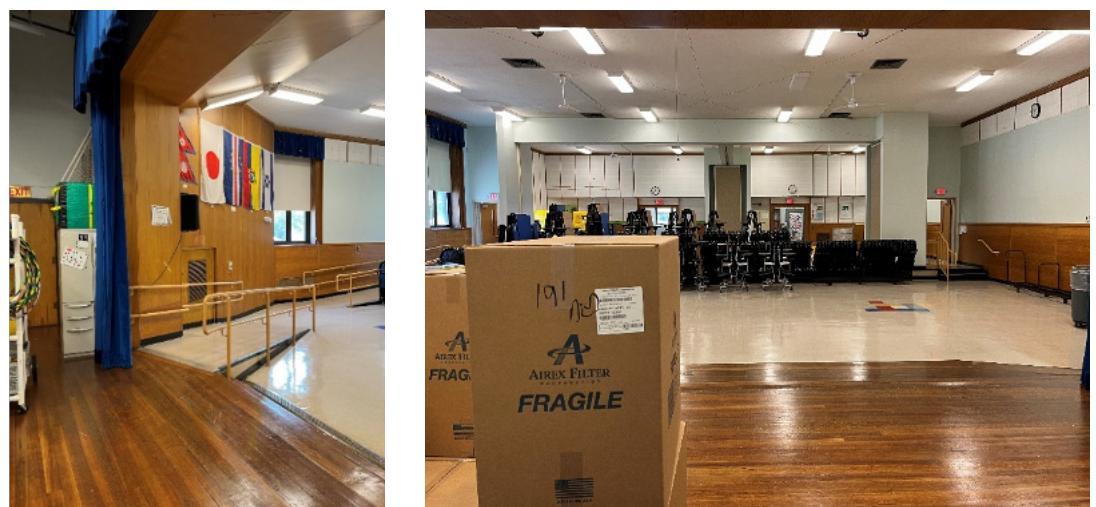
Cafetorium is heated and ventilated by the original system.

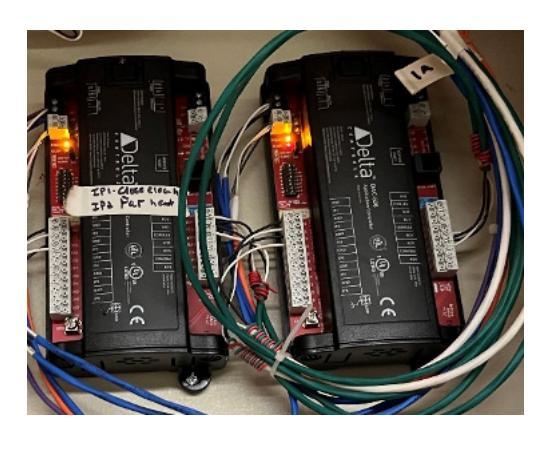
Delta DDC Controllers were found in the modular building.

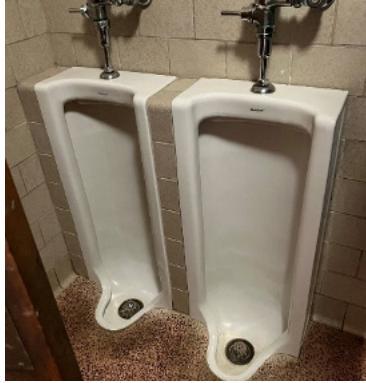
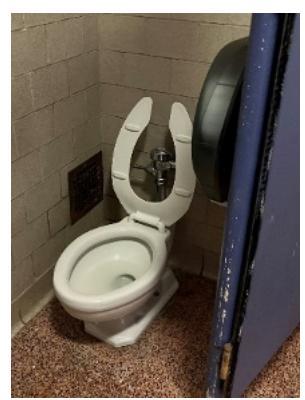
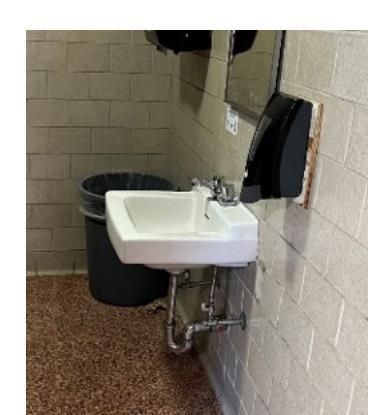
L - Urinals in the older part of the building are not code compliant. All - Vitreous china parts of the fixtures are original but are in fair condition. Faucets, flushometers and valves have been replkaced as needed and are in fair shape.

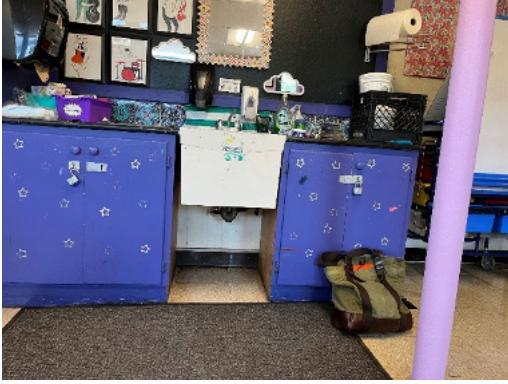
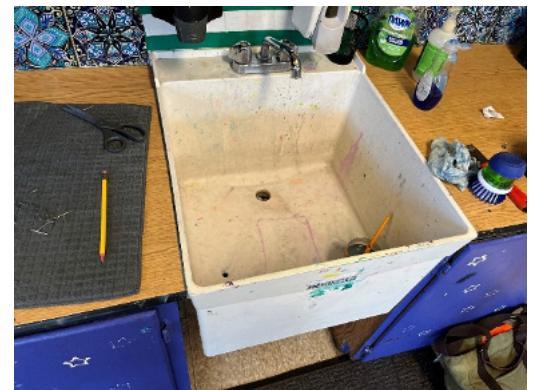
Art Room sink is residential laundry type sink, which is code compliant and functional but an unusual application for an institutional building.

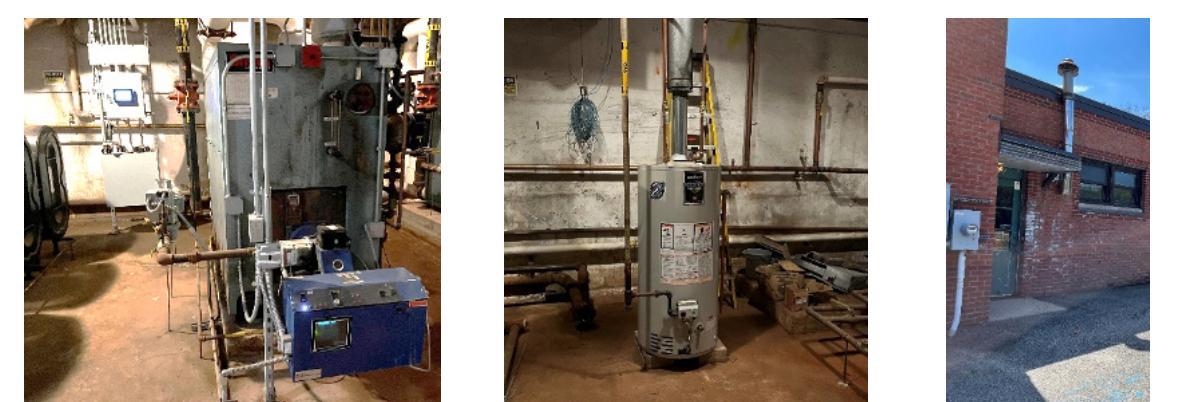
L - Boiler gas piping. C - Recently installed gas fired tank type domestic hot water heater. R - Heater flue.

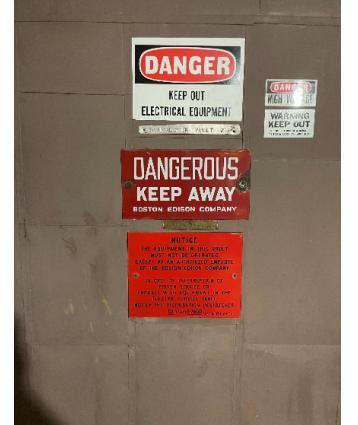
Transformer vault door. Need to confirm transformers have been removed.

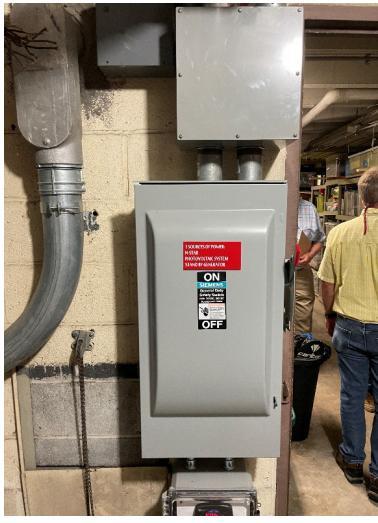
Service #1

Despite being maintained by the owner; many of the 1951 and 1957 electric service panels are still operational, and well past their life expectancy.

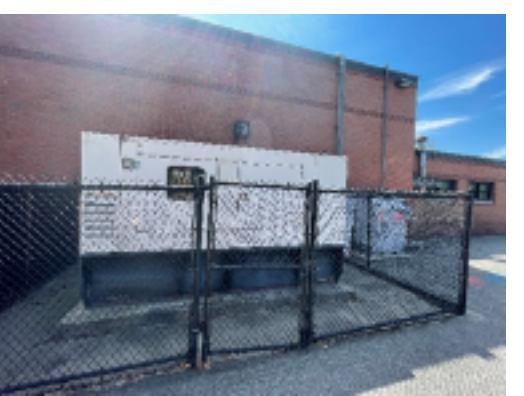
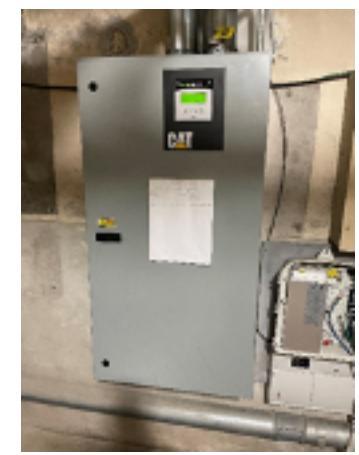
Generator with PV equipment adjacent

Transfer switch

Abandoned generator

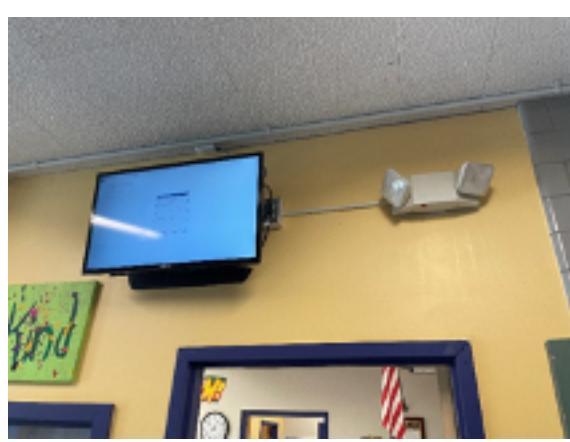
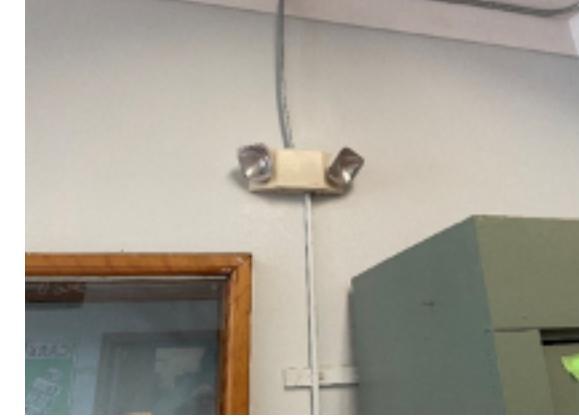
Emergency battery units

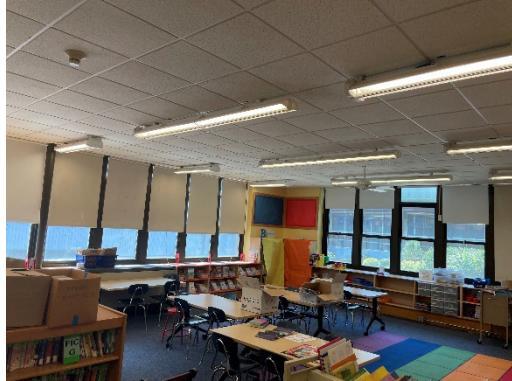
Overall quality of the lighting is fair to poor condition but the lighting creates glare. Glare was observed on whiteboards and computer screens.

Typical Classroom

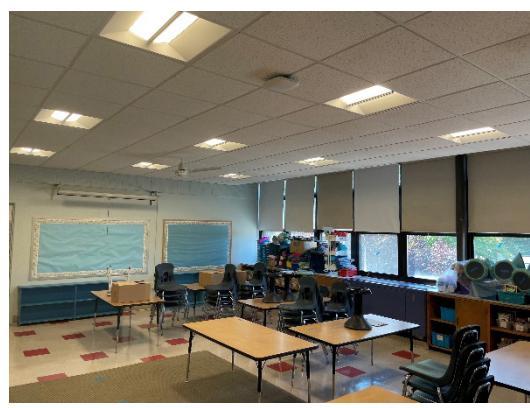
Typical Classroom

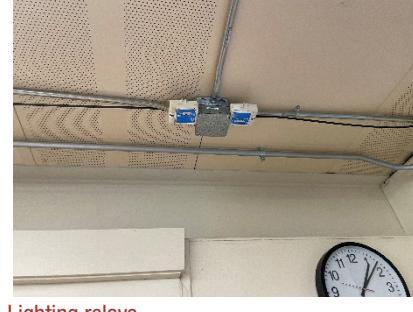
Lighting relays

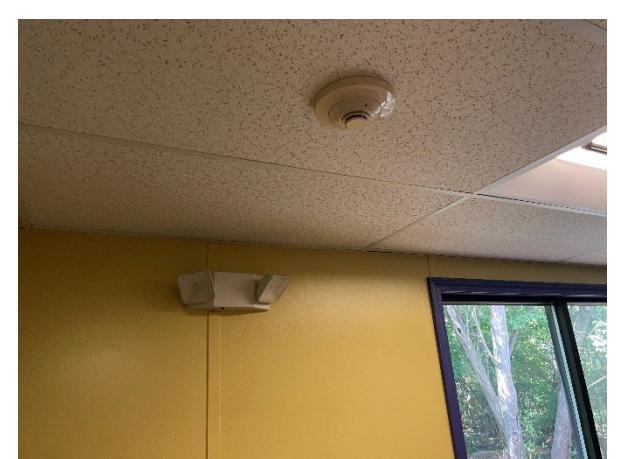
The fire alarm system is in poor to failing condition, well past its life expectancy, and needs to be replaced.

Smoke Detectors - Different models

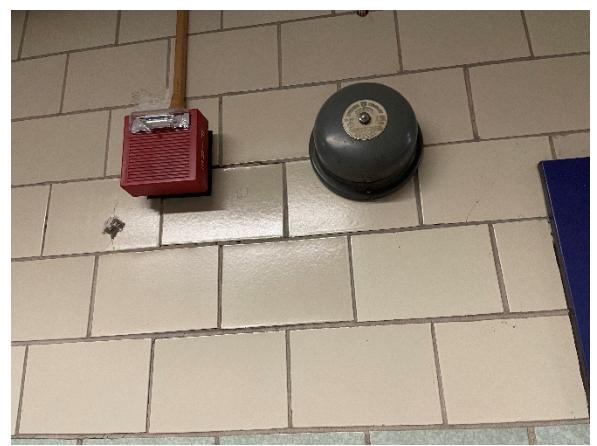
AV notification device and bell

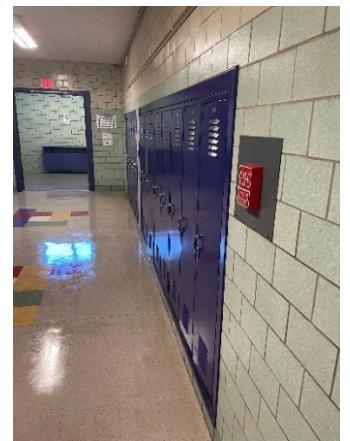
There are multiple fire alarm system code violations:

Pull station not at door

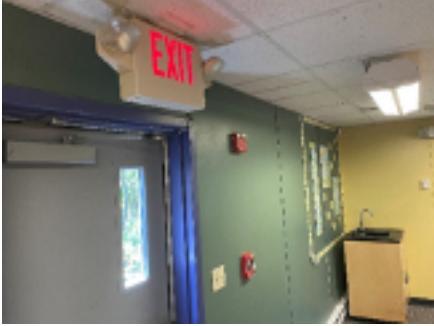
FA devices, emerg. lighting / exit sign

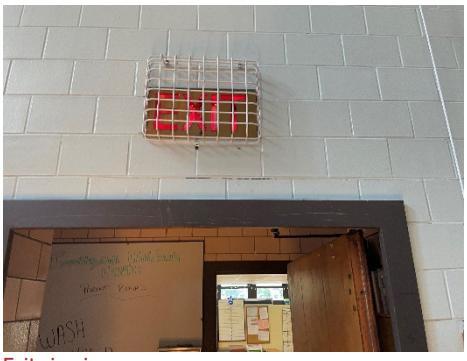
There appears to be exit signs in all paths of egress. There are several different generations of exit signs in the building. Overall exit signs conditions are fair.

Exit sign in gym

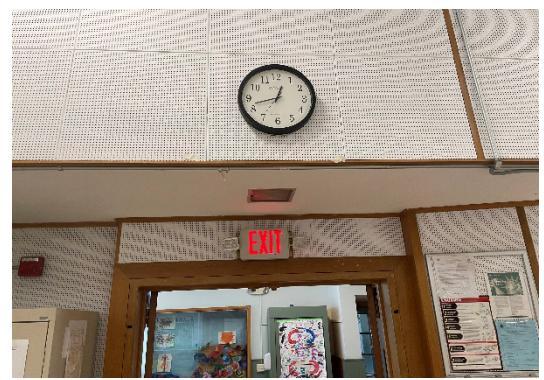
Exit sign with emergency lighting

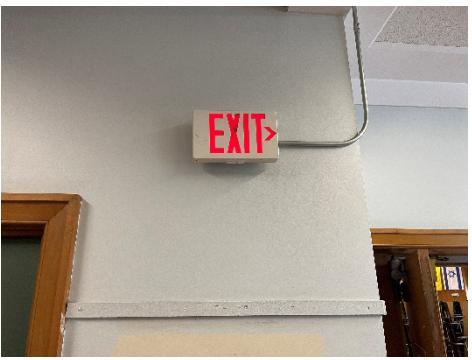
Exit Sign

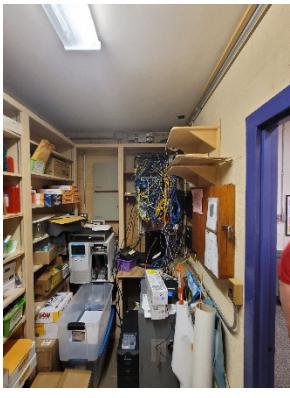
Figure 7

The School has Category 5e and 6 UTP data cabling installed throughout. Much of the data cabling has been added to the building over time and cable runs fully exposed in numerous locations outside conduit or raceway (Figures 1-5), with some cabling loosely contained in surface mount raceway (Figure 6).

All the voice and data a cabling appears to be in working order although it does not meet the latest cabling standards for structured cabling systems and does not meet building codes for the way it is installed. The MDF is comprised of a wall mount rack collocated at one end of an accessible storage closet in the administrative office area (Figure 7). Structured voice and data cabling is terminated onto wall mounted data patch panels in a wooden open frame wall cabinet. Building communication services including telephone and RCN fiber optics are terminated on the wall in this location (Figure 8). A telephone system controller is also located in this room. The room lacks security, power and environmental conditioning, or adequate cable management. There is a separate location high up on a wall in another shared space where additional cabling is terminated on a wall mount patch panel and connecting to a network switch that is sitting a shelf. It was assumed but not evident that this location was connect to the MDF via fiber optic cabling.

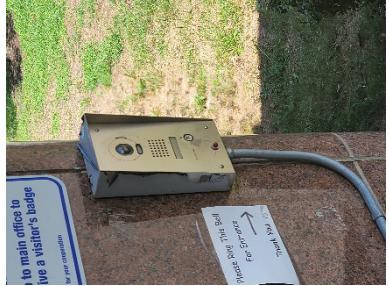
Figure 21

An Aiphone video intercom system with the capability of remote visual monitoring was observed at the main entrance to the building (Figure 21). This system has a management console in the main office for remotely viewing and communicating with visitors at the exterior of the building and unlocking the main

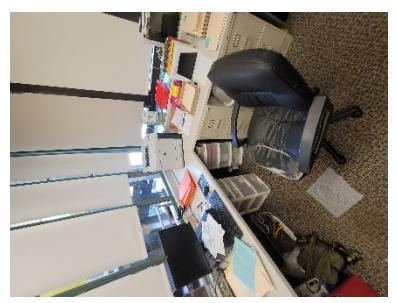
Figure 22

There is good visibility by the main office to anyone entering using the exterior video intercom system (Figure 22). However, the main vestibule provides no way to contain someone for processing once they are let into the building. A secured entry system for processing visitors to the building should be added.

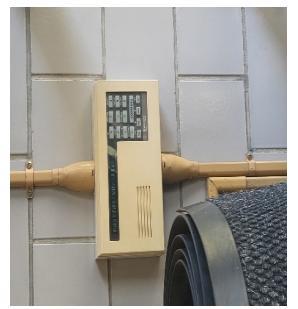
Figure 23

There is an older intrusion alarm system (figure 23) which most likely works with door contacts installed at exterior doors. Current motion sensor technology was not observed in corridors. Rooms on the ground floor with accessible windows do not appear to be equipped with motion sensors. An upgraded intrusion system with motion sensors in all ground floor rooms with windows with exterior door contacts should be considered.

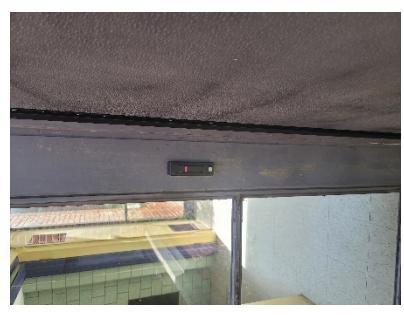
Figure 24

There is an access control system installed with Card Readers at various exterior doors including the main entrance (Figure 24)

Operation of the installed system was not observed.
